AMI Stadium - East Stand Development Construction

Introduction to the Project

This waste reduction case study demonstrates that with careful on-site and off-site waste sorting, 77% of construction waste can be recovered for reuse and recycling.

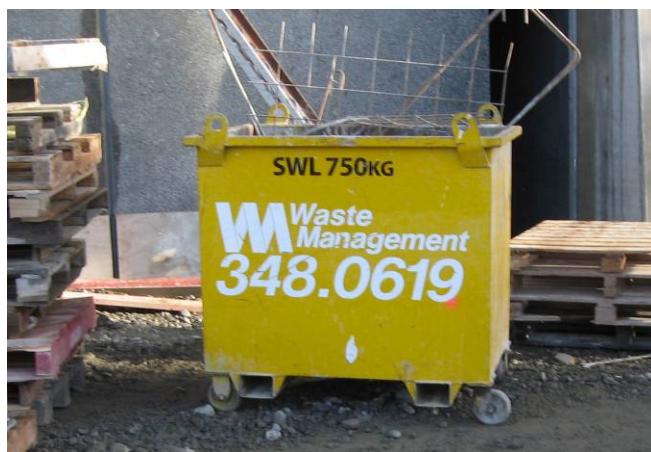
Bucket skips used to transport waste to the central sorting area © Copyright

- Separate skips and bins were clearly labelled.
- Initially sorted materials into small (bucket) skips and then removed these to the central construction waste sorting area. Fletchers allocated one full-time staff member to sort the waste in the smaller bins into the separate recycling and waste skips.

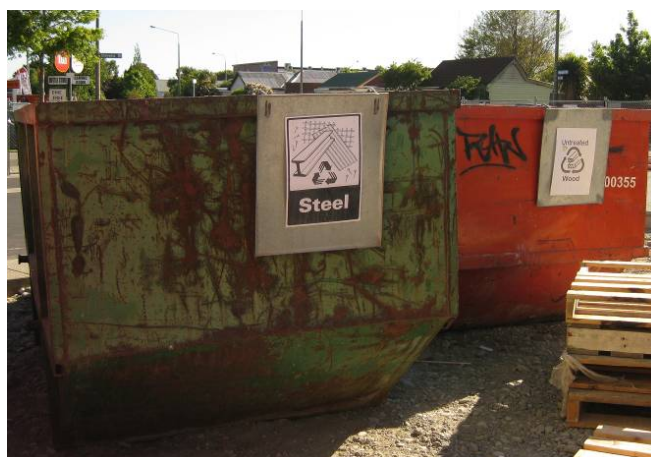
Clearly labeled skips for on-site waste sorting © Copyright

The use of skips and further off-site waste sorting was undertaken to ensure maximum recovery of materials for reuse and recycling. Waste Management provided separate skips and wheelie bins for the separation of different waste streams on-site.

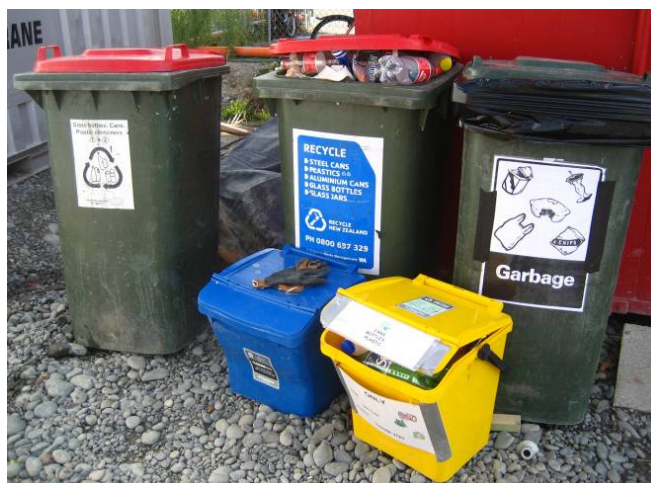
Central waste station for non-construction waste © Copyright

- Had separate waste, paper and recycling wheelie bins for staff and sub-contractors lunch and office waste.
- Sent pallets back to suppliers for reuse or sent to Pallet Improvements for reuse/recycling.
