AMI Stadium - East Stand Development Demolition

Introduction to the Project

Site: AMI Stadium - East Stand

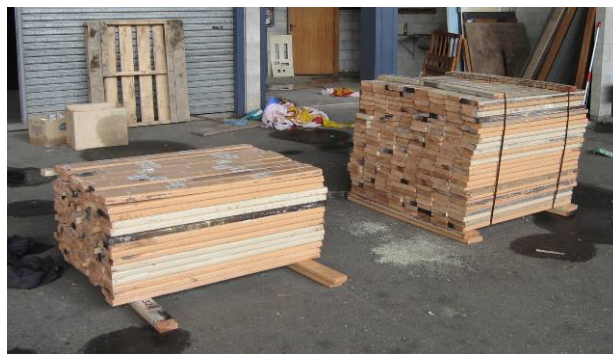
Wooden floor boards recovered for resale © Copyright

- Prepared a waste management plan with clear waste targets.
- Inducted all staff to the waste management plan.
- Held daily meetings to plan the days salvage activities.
- Initially removed materials by hand e.g. wooden floor boards and then bought in a high reach arm to remove steel and concrete as they deconstructed.
- Separated materials and stored them on-site in neat piles.
- Removed re-bar from the concrete and crushed the concrete on-site using a mobile concrete crusher.

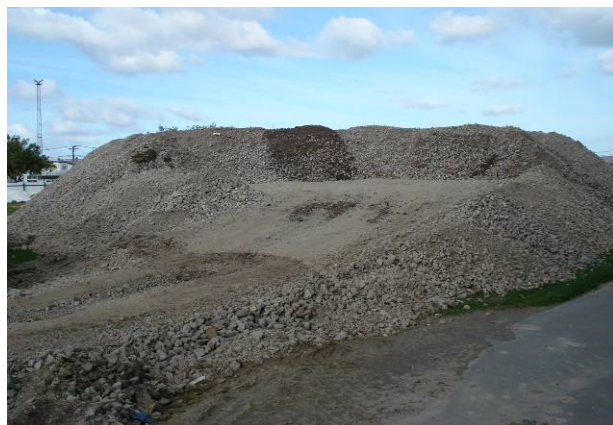
Concrete crushed for reuse on-site © Copyright

Waste Materials	Reuse and Recycling		Disposal	Comments
	On-site (tonnes)	Off-site (tonnes)	Off-site (tonnes)	
Concrete	6,053			This was crushed and used on site for new foundations, roading and parking areas.
Vegetation / green waste		28		This was removed, sent to ECO Recycling Park, and chipped for use as a garden product.
Metal		900		This was sent to various scrap metal dealers in Christchurch for recycling.
Plasterboard		65		This was removed and crushed and reused for soil conditioner on farms.
Timber (treated)		12		This was sent to ECO Recycling Park where it was prepared for resale.
Seats		15		50 seats were given to charity/fund raising activities and 325 were sold. The remainder will be sold though the Southern Demolition yard and TradeMe.
Building components (steel portals)		8		These were removed by Southern Demolition and sent to the Southern Demolition Salvage Yard.
Plastics			0.1	This was sent to Metro Transfer Station. It was not recyclable as some plastic was contaminated and not able to be separated.

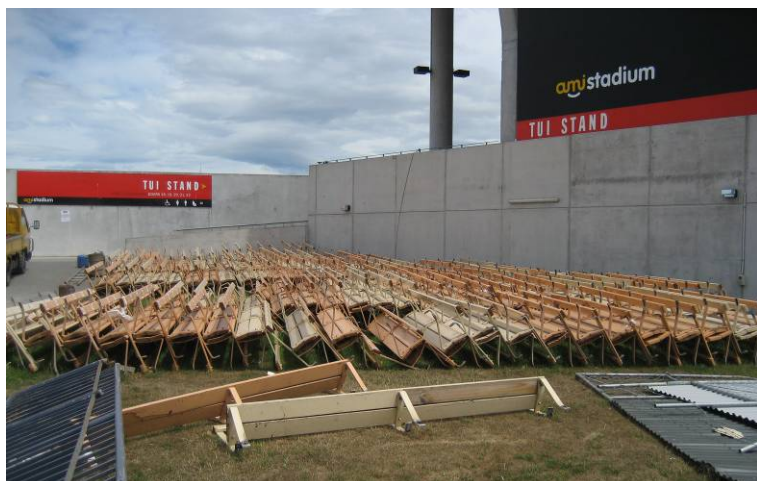
Seats recovered for reuse © Copyright

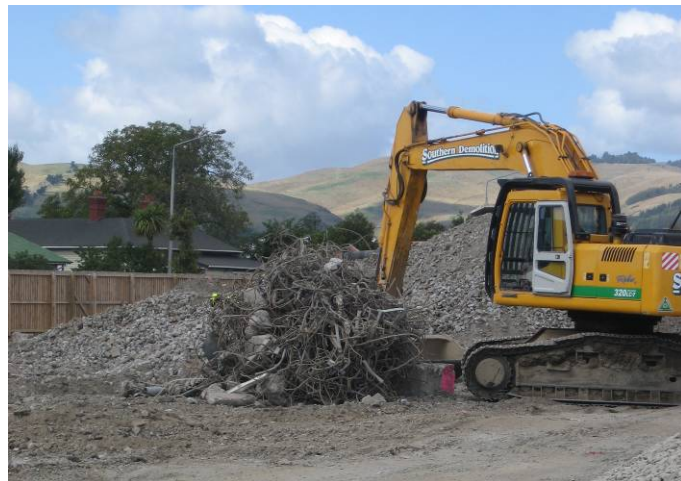
Re-bar being removed from the crushed concrete prior to crushing © Copyright
